STABILITY RESULTS OBTAINED WITH DOUGLAS D-558-1 AIRPLANE

(BuAero No. 37971) IN FLIGHT UP

TO A MACH NUMBER OF 0.89

William H. Barlow and Howard C. Lilly

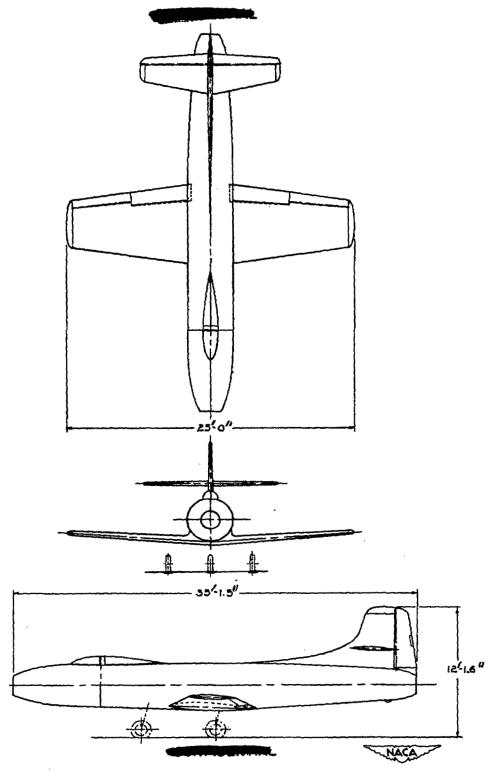
Figure 2.- Three-view drawing of D-558-1 airplane.

The Douglas D-558-1 airplane is a single-place low-wing monoplane powered by a General Electric TG-180 turbojet engine. General views of the airplane are given in figures 1(a), 1(b), and 1(c). A three-view drawing of the airplane is given in figure 2. Detailed specifications of the airplane are given in reference 1.

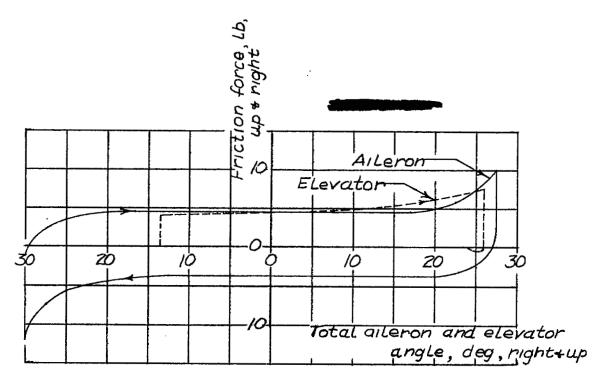
Figure 3.— Control friction forces obtained by moving controls slowly in direction shown. D-558-1 airplane.

The force required to move the wheel controls slowly under static airplane conditions is shown in figure 3. The rudder friction is of the order of 7 pounds near neutral position. The elevator control has a bungee tending to return the elevator to the down position. All controls have hydraulic dampers at the control surface which necessitate high control force for rapid motion of control.

of acceleration. With the 1.4° stabilizer setting in figure 6 the airplane became increasingly tail heavy above a Mach number of 0.83. During the recovery in this run (65 to 89 sec and M = 0.88 to 0.834) the pilot merely decreased the push force and a normal recovery was effected. The pilot reported that in both runs, there was buffeting which began at about a Mach number of 0.85. It is also interesting to note that above a Mach number of 0.84, the airplane becomes very right-wing heavy and the pilot applied control to correct it. The pilot reported that this wing heaviness was not continuous and it was difficult to determine the lateral control required for trim. As a consequence, the airplane felt uncertain laterally at the highest speeds as can be seen by the control motions used by the pilot, and the lateral oscillations which resulted. Some of this uncertainty in lateral trim may arise from aileron friction. (See fig. 3.)

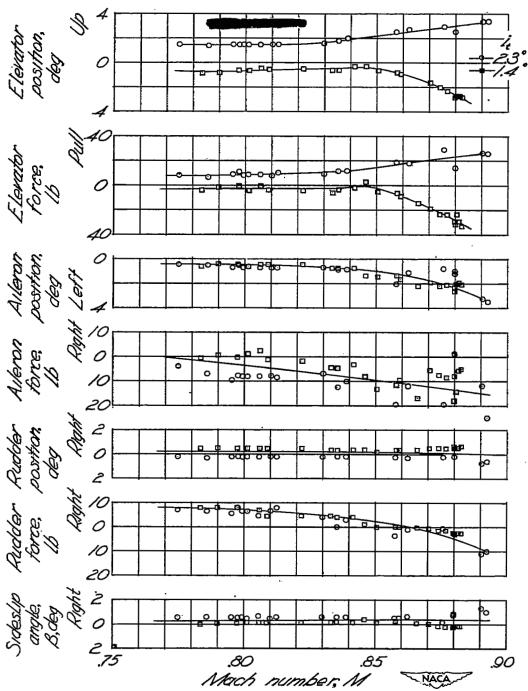
Figure 7.- Variation of airplane trim forces and positions with Mach number. (C. \$23 to \$3) D-558-1 airplane.

In order to illustrate further the control required by the pilot to trim the airplane, control positions and forces and sideslip angle for steady flight were selected from figures 5 and 6 and plotted in figure 7 as functions of Mach number. In this figure, the difference in control required for trim caused by the two stabilizer settings is clearly shown. These trim changes, from the standpoint of pilot's forces, are large in that approximately 30 pounds force was required in either the pull or push direction, depending on the stabilizer setting. In the case of the Bell XS-1, data for two stabilizer settings showed no difference in the direction of the trim change as the airplane becomes nose heavy in both cases (reference 4) for this Mach number range. The right-wing heaviness is illustrated in this figure by the increased left aileron for trim required at the higher speeds. There was no appreciable change in rudder position or sideslip angle. (A similar phenomenon of wing heaviness was noted with the XS-1 airplane (reference 4).)

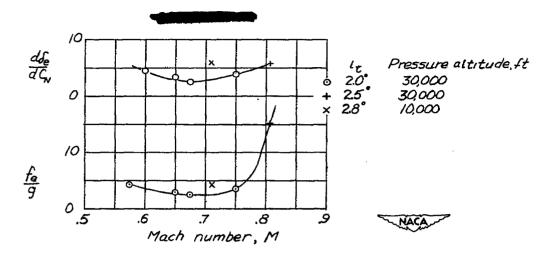
Figure 8.- The variation of stick force per g, f_{g} , and the change in elevator angle per unit G_{N} , $d\delta_{Q_{N}}$, with Mach number. D-558-1 airplane.

Some stability and control data in accelerated flight were obtained from steadily increasing turns made at an altitude of 30,000 feet in a Mach number range from 0.50 to 0.80 and one turn made at 10,000 feet at a Mach number of 0.71. The results of these measurements are given in figure 8 where the stick force per g and elevator angle required per unit CN are plotted as functions of Mach number. These data show that the longitudinal stability is positive throughout the speed range and is lowest at about a Mach number of 0.675. Above a Mach number of 0.675, the stability increases with increasing Mach number. These results are in general agreement with the data obtained on the Bell XS-1 airplane (reference 5). Although data were available only at one speed for an altitude of 10,000 feet, it is interesting to note that the apparent stability is higher at 10,000 feet than at 30,000 feet. Some of this difference can be accounted for by the effect of altitude but it is also possible that, because of the higher dynamic pressure at the lower altitudes, the apparent stability is altered by distortion effects.

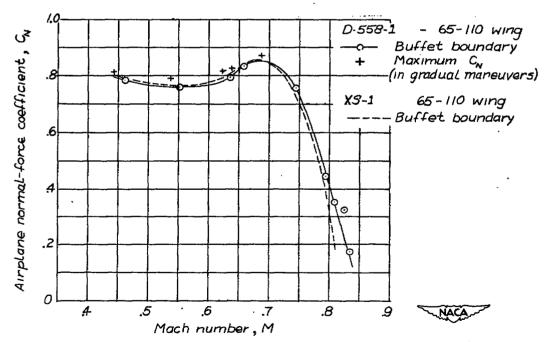
Figure 9.— Buffet boundary of D-558-1 airplane compared with buffet boundary of X5-1 airplane.

measurements are given in figure 9 where the normal-force coefficients necessary for buffeting are plotted as functions of Mach number. The buffet boundary as presented in this figure defines the combination of Mach number and normal-force coefficient where buffeting begins. Below a Mach number of 0.70, the airplane was flown into the buffet boundary and the test points shown beyond the boundary represent maximum lift for a gradual maneuver at the test speed. Above a Mach number of 0.70, the airplane was flown into the buffet region but peak lift was not obtained during the tests. For comparison, the buffet boundary for the Bell XS-1 airplane with the same wing section 65-110 (references 4 and 6) is also shown in this figure. As might be expected, the buffet boundaries for the two airplanes are quite similar.
